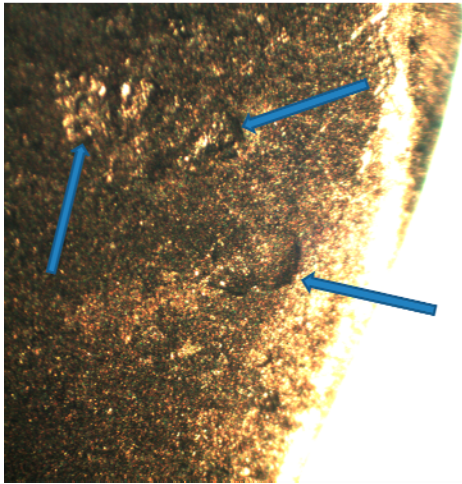
Fig. E-1  
Light microscopy image of the interfacial surface of the distal aspect of the modular neck. Pitting and scarring of the surface (arrows) are evident at low magnification.

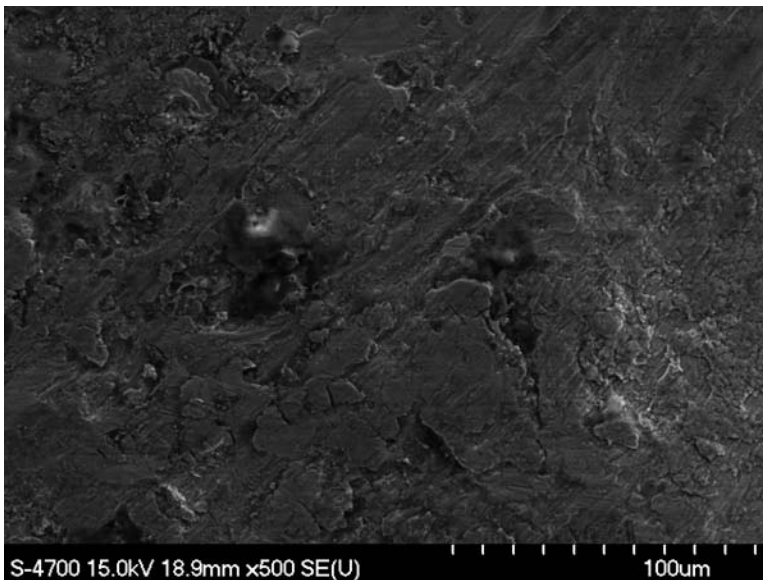
Fig. E-2  
Scanning electron microscopy image of the interfacial surface of the distal aspect of the modular neck. Microscopic pitting and scarring are apparent at high magnification.

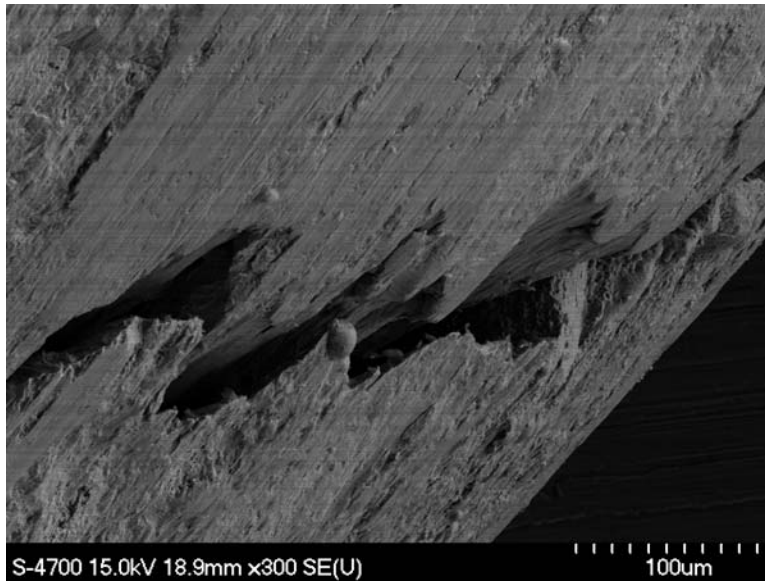
Fig. E-3  
Scanning electron microscopy image showing a crack near the fracture site in the modular neck.
